QA-58
Spread Eagle
Church Hill
Private

MARYLAND HISTORICAL TRUST

INVENTORY FORM FOR STATE HISTORIC SITES SURVEY

Spread Eagle Farm

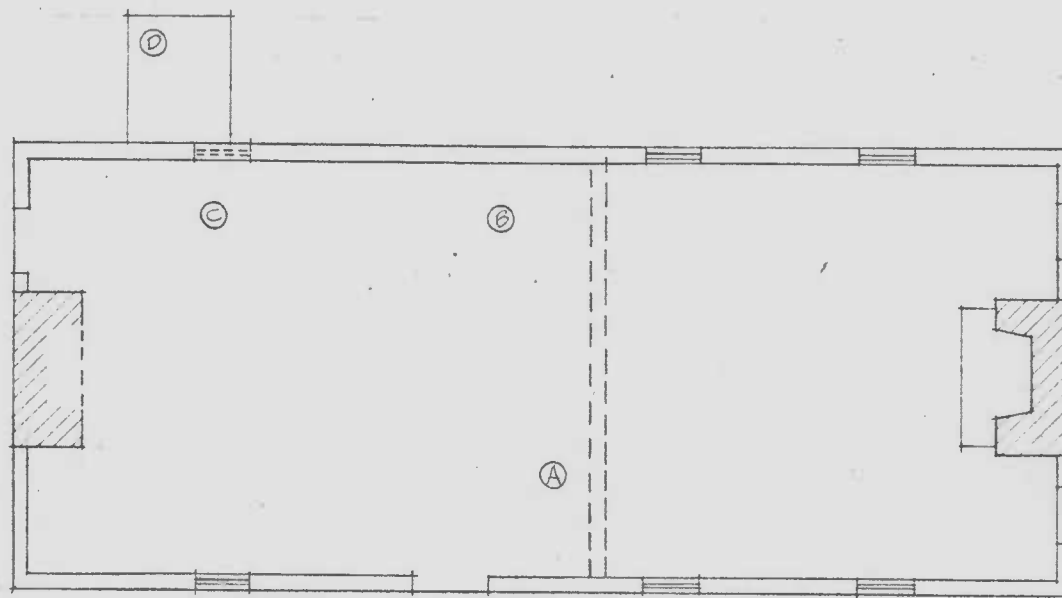
SPREAD EAGLE
CHURCH HILL, MARYLAND

- A LOCATION OF ORIGINAL PARTITION
- B PROBABLE LOCATION OF ORIGINAL STAIR
- C ORIGINAL $\frac{1}{8}$ " WINDOW REPLACED BY MODERN PICTURE WINDOW
- D BULKHEAD ENTRANCE TO CELLAR

SCALE: $\frac{1}{8}$ " = 1'-0"
